DITCHING TESTS WITH A $\frac{1}{11}$ -SIZE MODEL OF THE

ARMY B-25 AIRPLANE IN NACA TANK NO. 2

AND ON AN OUTDOOR CATAPULT

NACA CMR No. L4J11

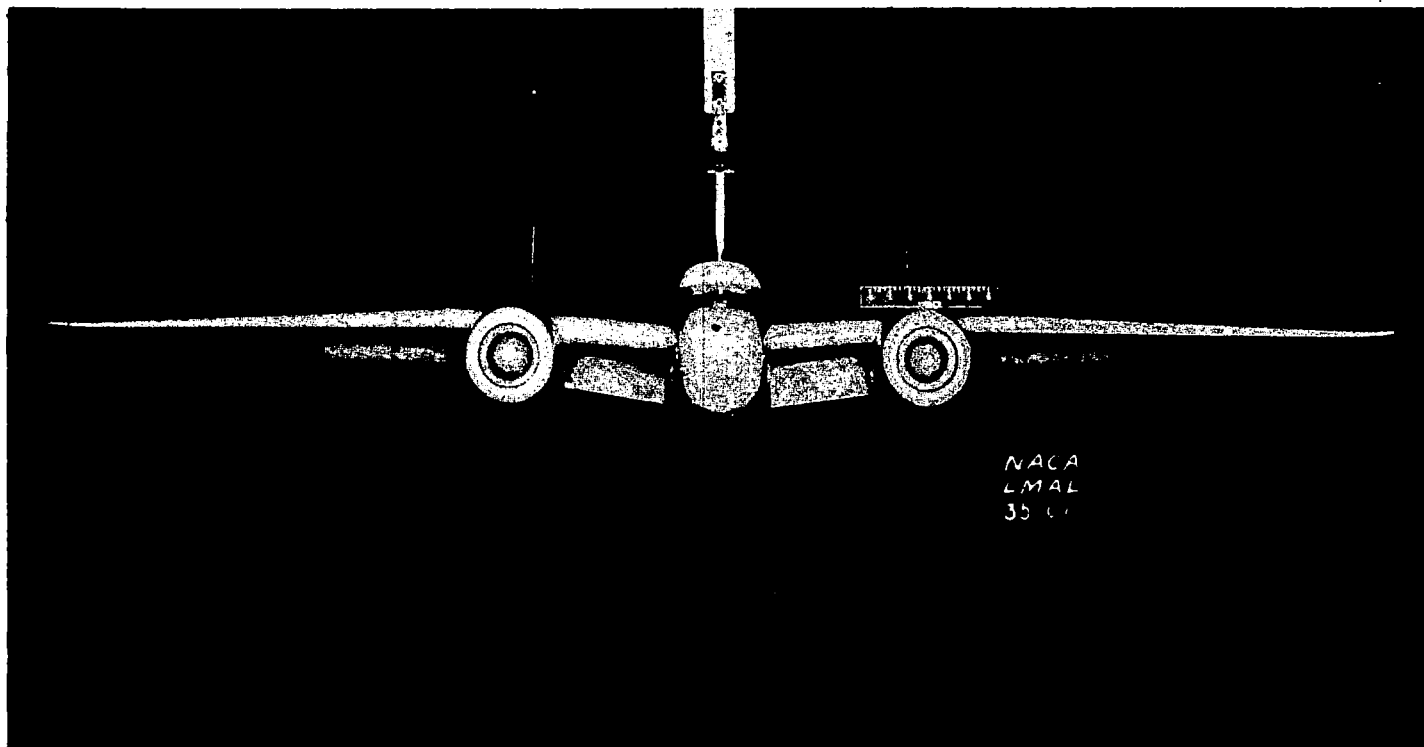
Figure 1a.- Front view of a $\frac{1}{11}$ -size model of the B-25 airplane.

Photographs.- B-25B, B-25C, B-25D (fig. 1); B-25G, (fig. 2).

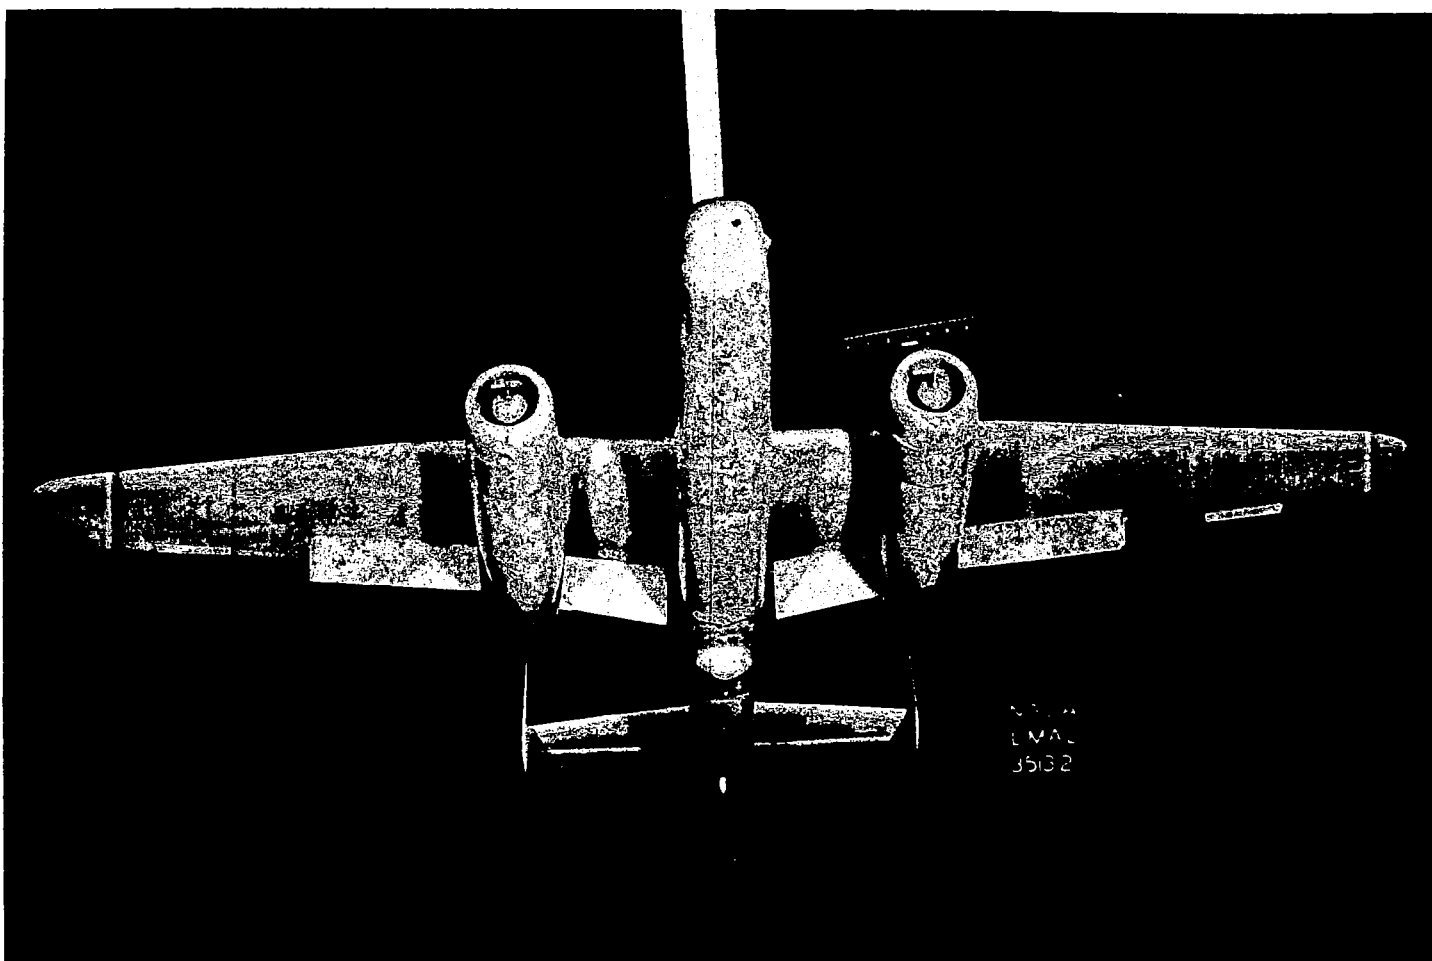
Figure 1b.- Bottom view of a $\frac{1}{11}$ -size model of the B-25 airplane.

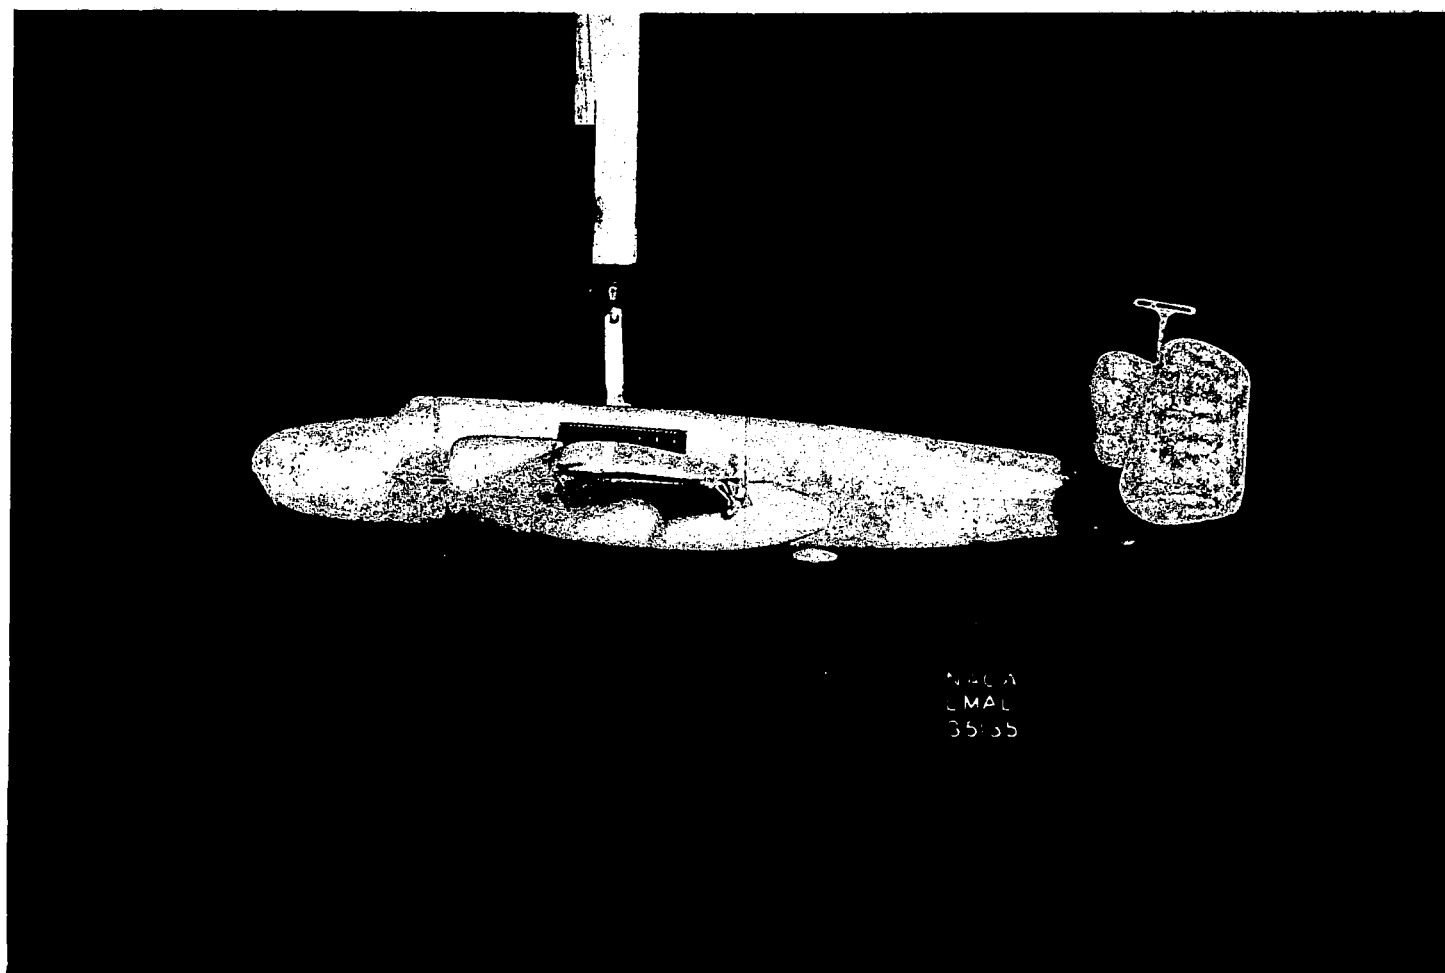
Figure 1c.- Side view of a $\frac{1}{11}$ -size model of the B-25 airplane.

- (a) No damage (fig. 1(c))
- (b) Model complete with $2\frac{3}{4}$ -inch projection from the fuselage skin at after edge of the bomb bays (fig. 3) (simulates denting or tearing of the bottom)
- (c) Model complete with $5\frac{1}{2}$ -inch projection from the fuselage skin at after edge of the bomb bays (fig. 3) (simulates denting or tearing of the bottom)
- (d) Bomb-bay and wheel doors, bombardier's windows, camera hatch, and bulkhead at after end of the bomb bay all removed (fig. 4) (catapult tests were made at this condition)
- (e) Same as (d) plus failure of entrance hatches (fig. 5)
- (f) Same as (e) except bulkhead in after end of bomb bay left intact (fig. 6)

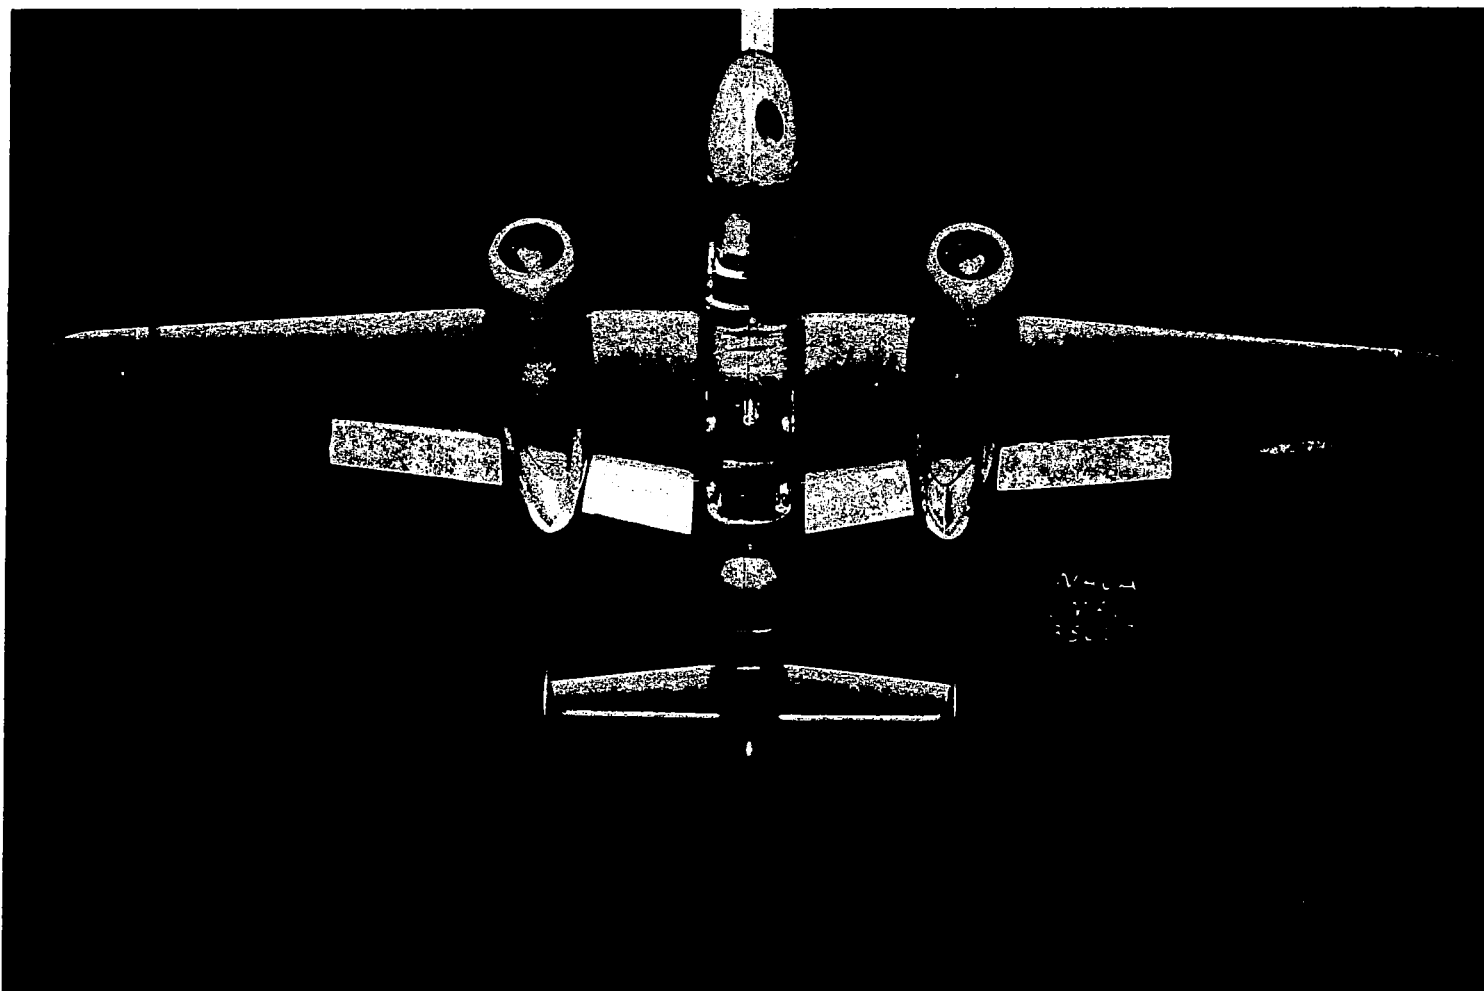
Figure 2a.- Bottom view of a $\frac{1}{11}$ -size model of the B-25G airplane, showing openings cut out to simulate failure of the wheel doors, bomb-bay doors, camera hatch, and bulkhead at the after end of the bomb bay.

- (a) Bomb-bay and wheel doors, camera hatch, and the bulkhead at the after end of the bomb bay all removed (fig. 2)

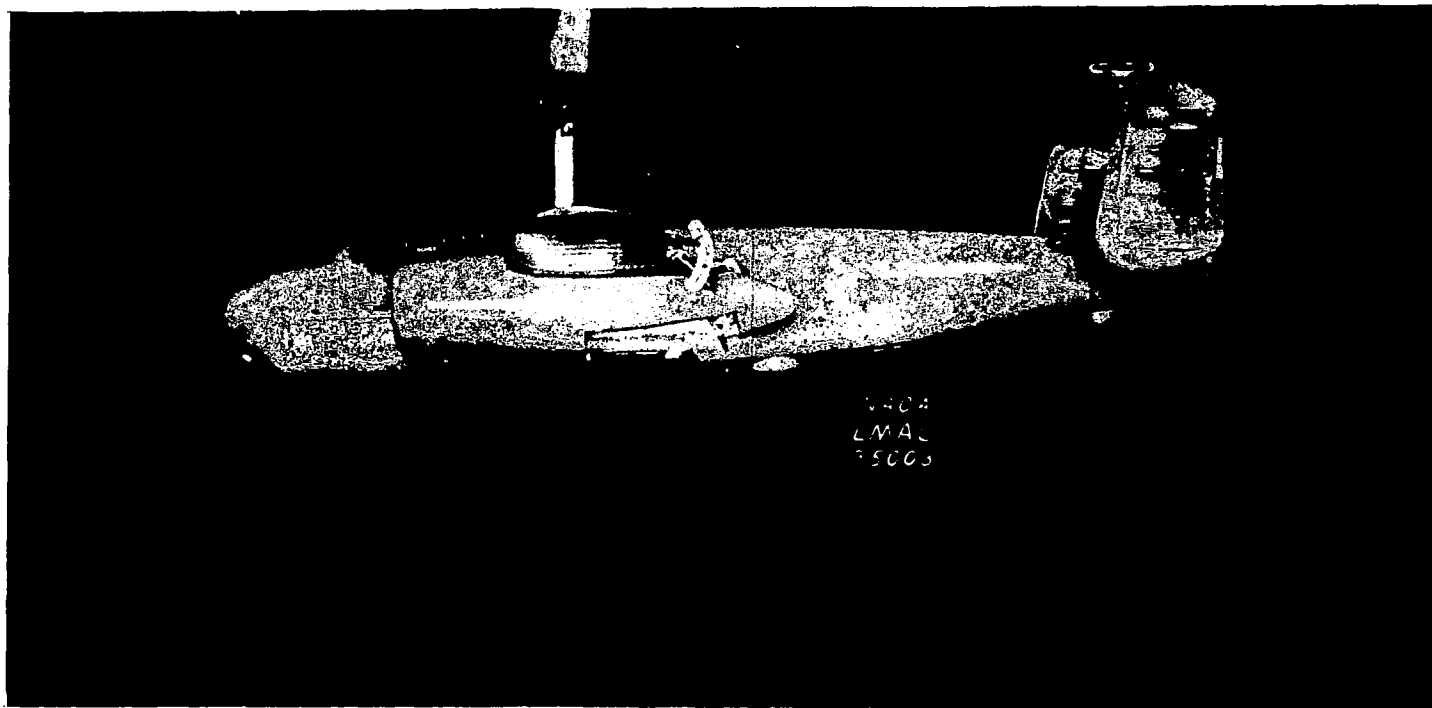
Figure 2b.- Side view of a $\frac{1}{11}$ -size model of the B-25G airplane showing openings cut out to simulate failure of the wheel doors, bomb-bay doors, and camera hatch.

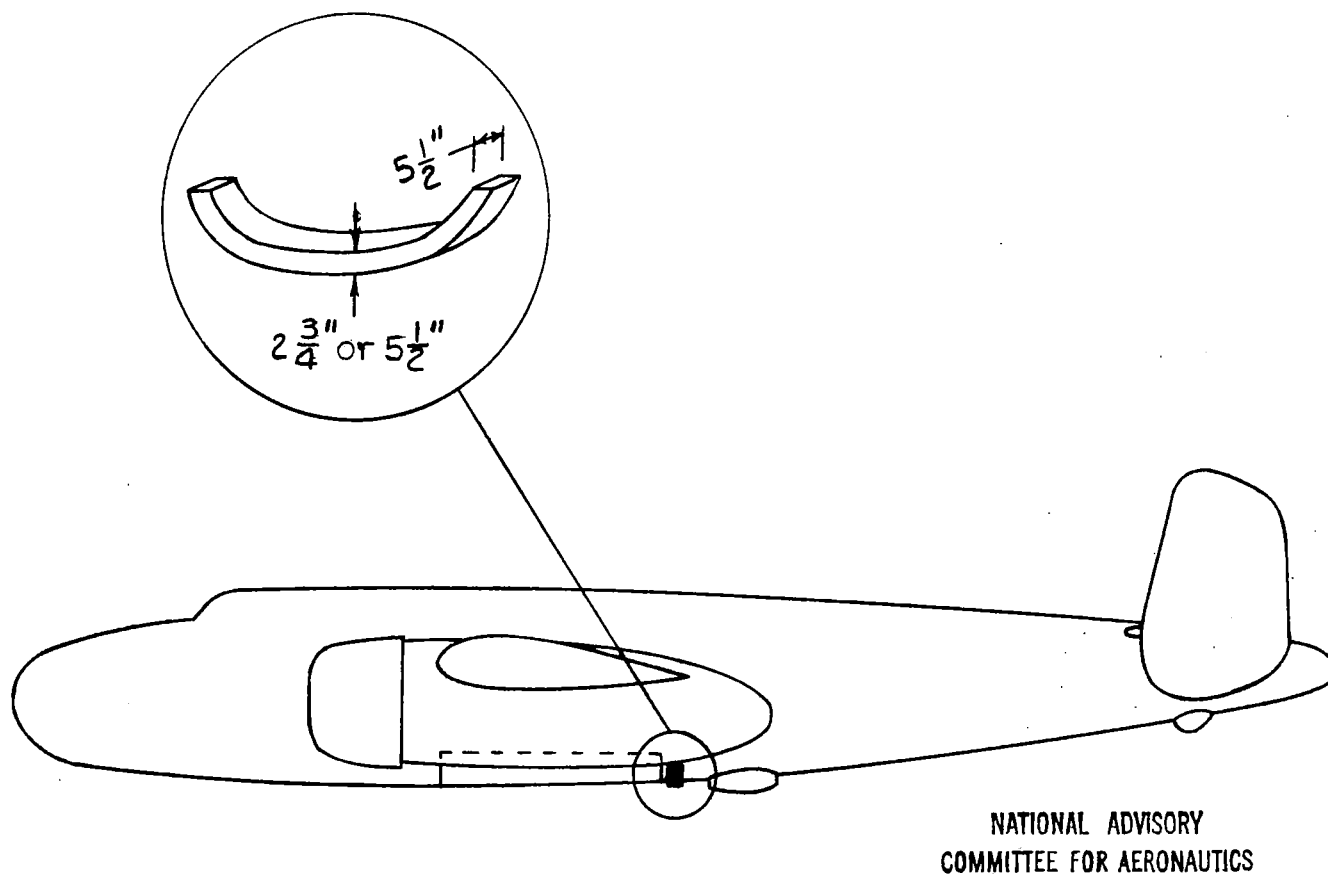
Figure 3. - Projecting ridge as tested on the model of the B-25 airplane.
(Dimensions are for the full-size airplane.)

A ridge was added to the fuselage of the model just aft of the bomb doors to represent a damaged condition of the structure. When the ridge height was increased to $5\frac{1}{2}$ inches (full size), violent dives occurred. This projection was rigidly attached and the results are probably pessimistic since projecting parts due to damage would probably be flexible and would not offer such great resistance to the water.

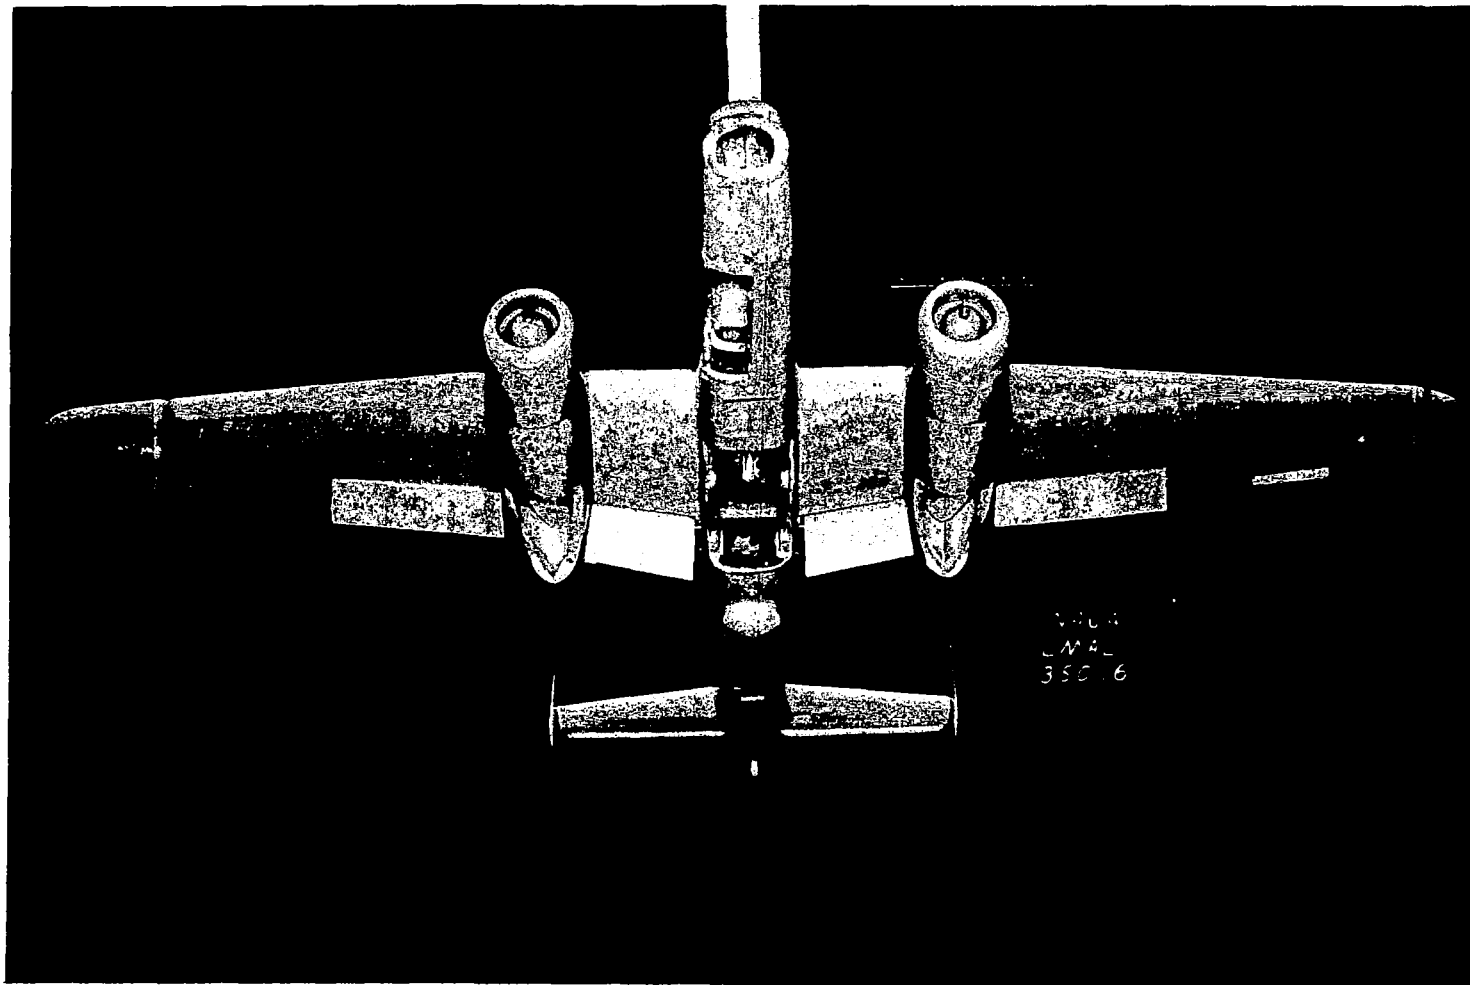
Figure 4.- Photograph of a $\frac{1}{11}$ -size model of the B-25 airplane with simulated damage of wheel and bomb-bay doors, camera hatch, bombardier's window, and the bulkhead at the after end of the bomb bay.

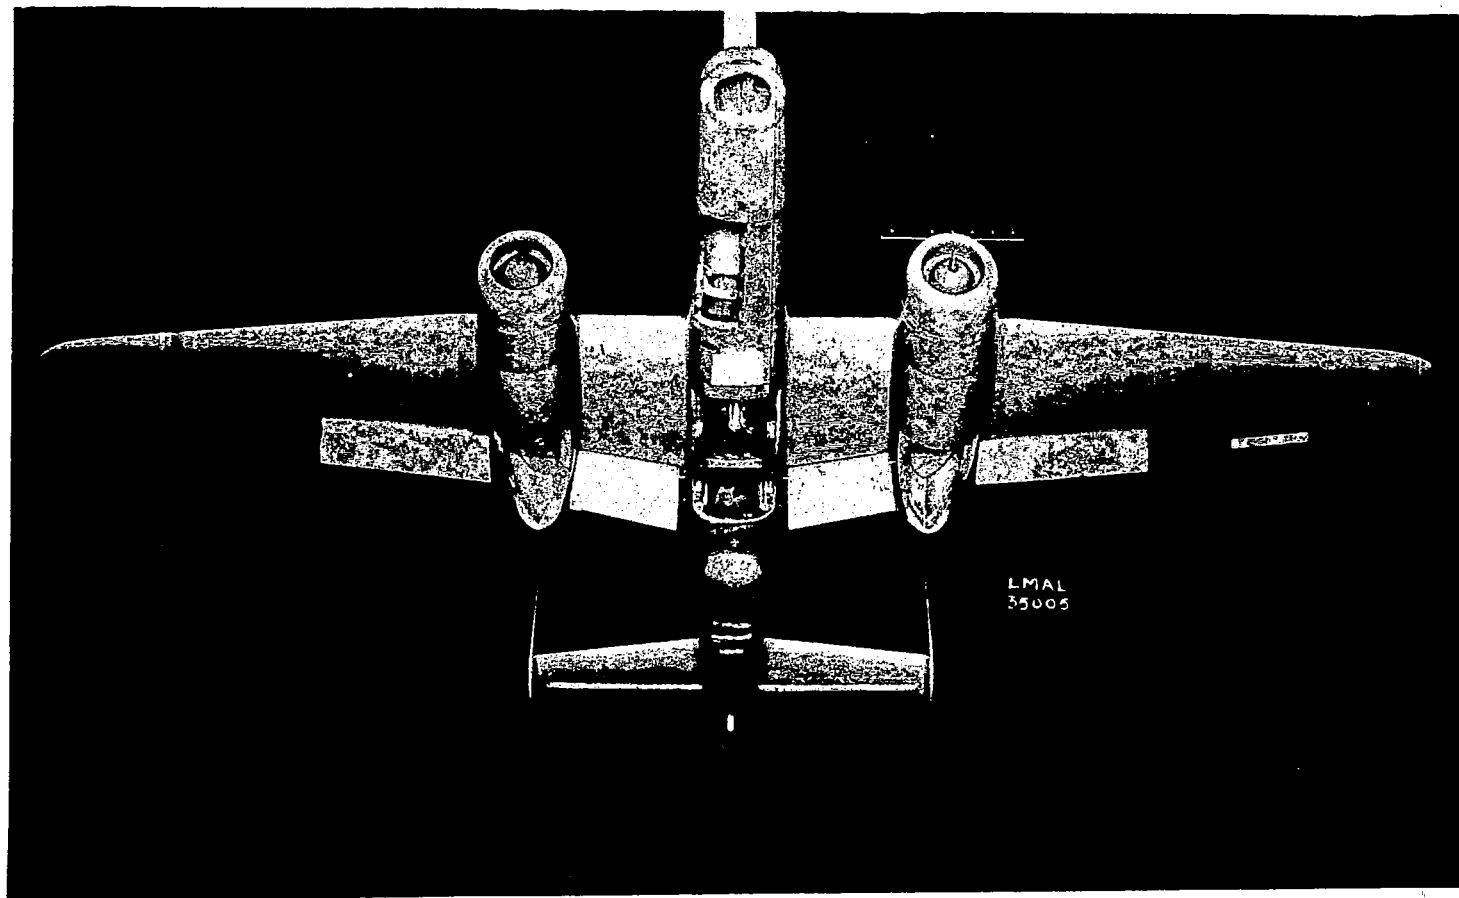
Figure 5.- Photograph of a $\frac{1}{11}$ -size model of the B-25 airplane with simulated damage of wheel and bomb-bay doors, camera and entrance hatches, bombardier's window, and the bulkhead at the after end of the bomb bay.

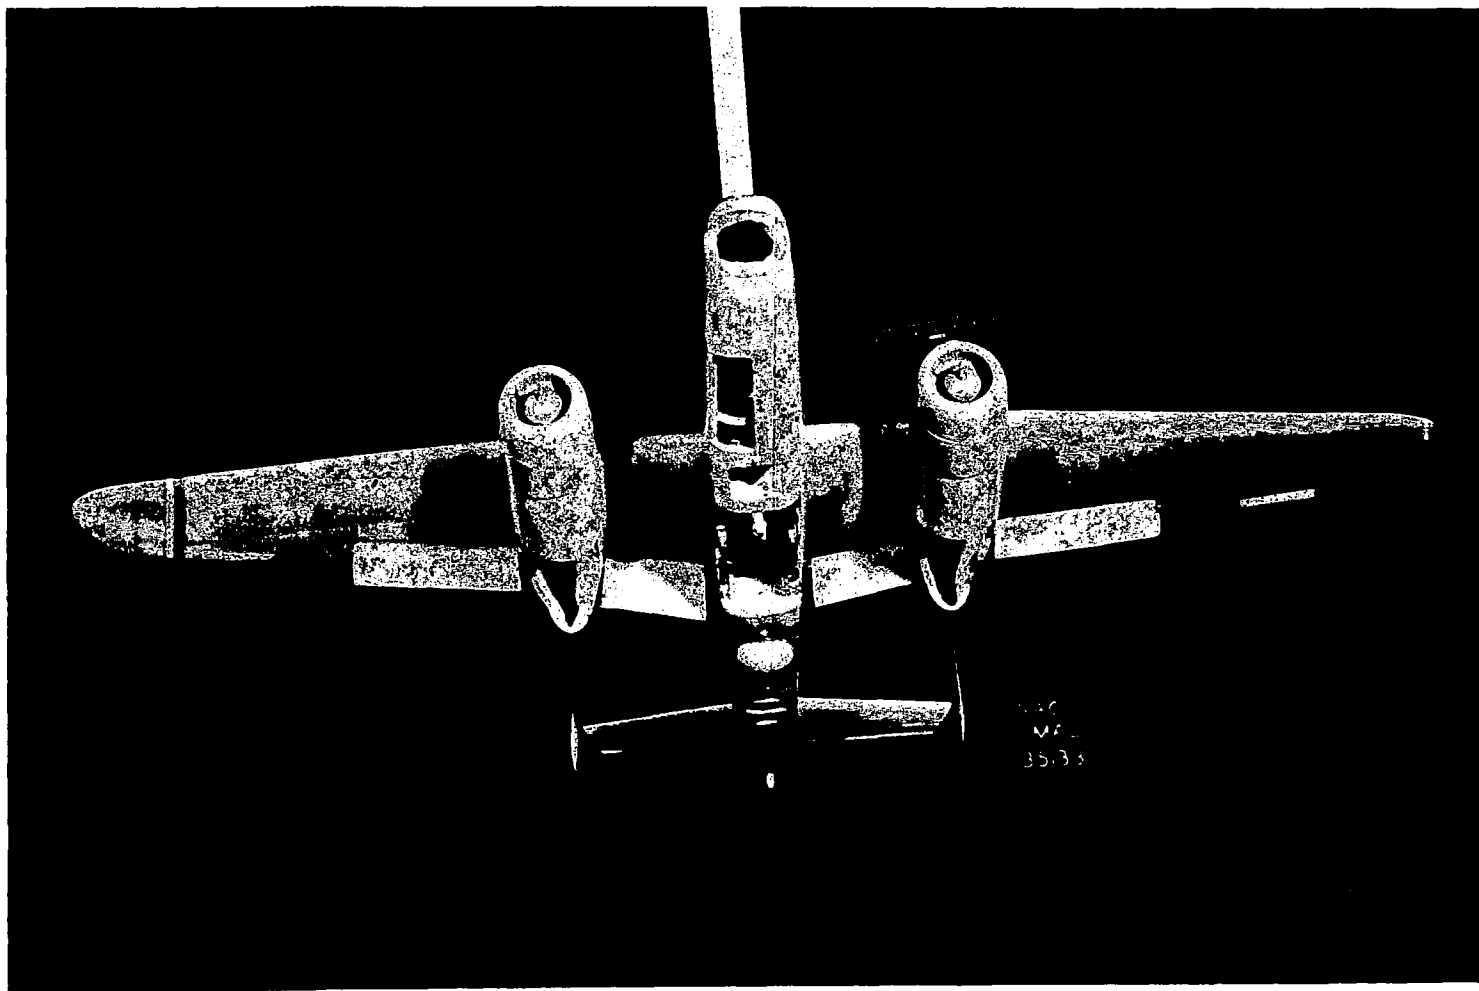
Figure 6.- Photograph of a $\frac{1}{11}$ -size model of the B-25 airplane with simulated damage of wheel and bomb-bay doors, camera and entrance hatches, and bombardier's window.

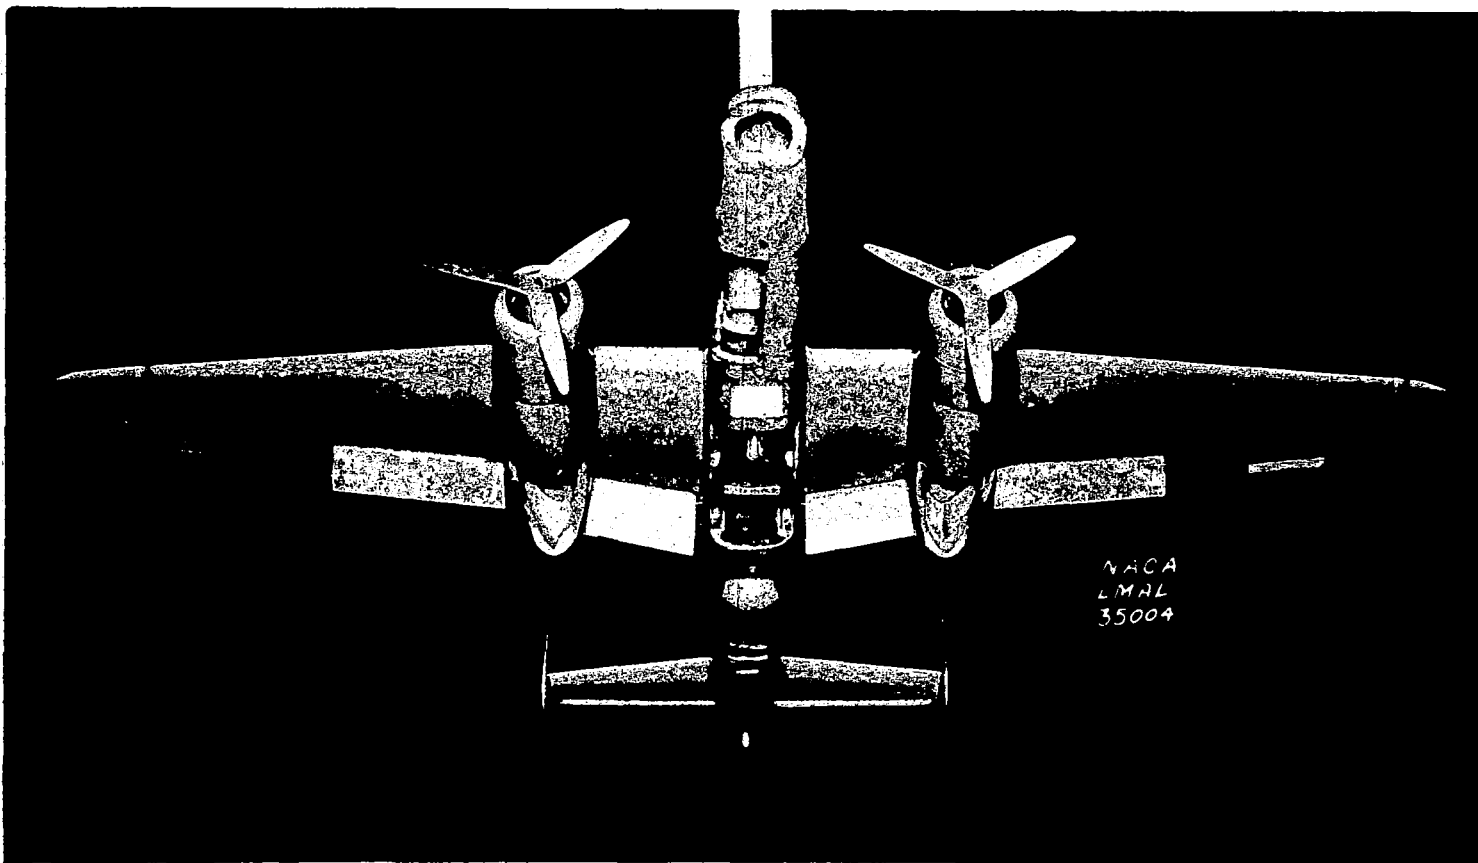
Figure 7.- Photograph of a $\frac{1}{11}$ -size model of the B-25 airplane with propellers.

Propellers. - The effect of propellers was determined with windmilling propellers. The damage simulated was the same as in I(e) above (fig. 7).

Effect of propellers.- The windmilling propellers increased the maximum deceleration and shortened the length of landing run. The results may be somewhat pessimistic because the propellers did not bend at the tips but, even so, these results indicate that the propellers were not severely detrimental to the ditching characteristics.

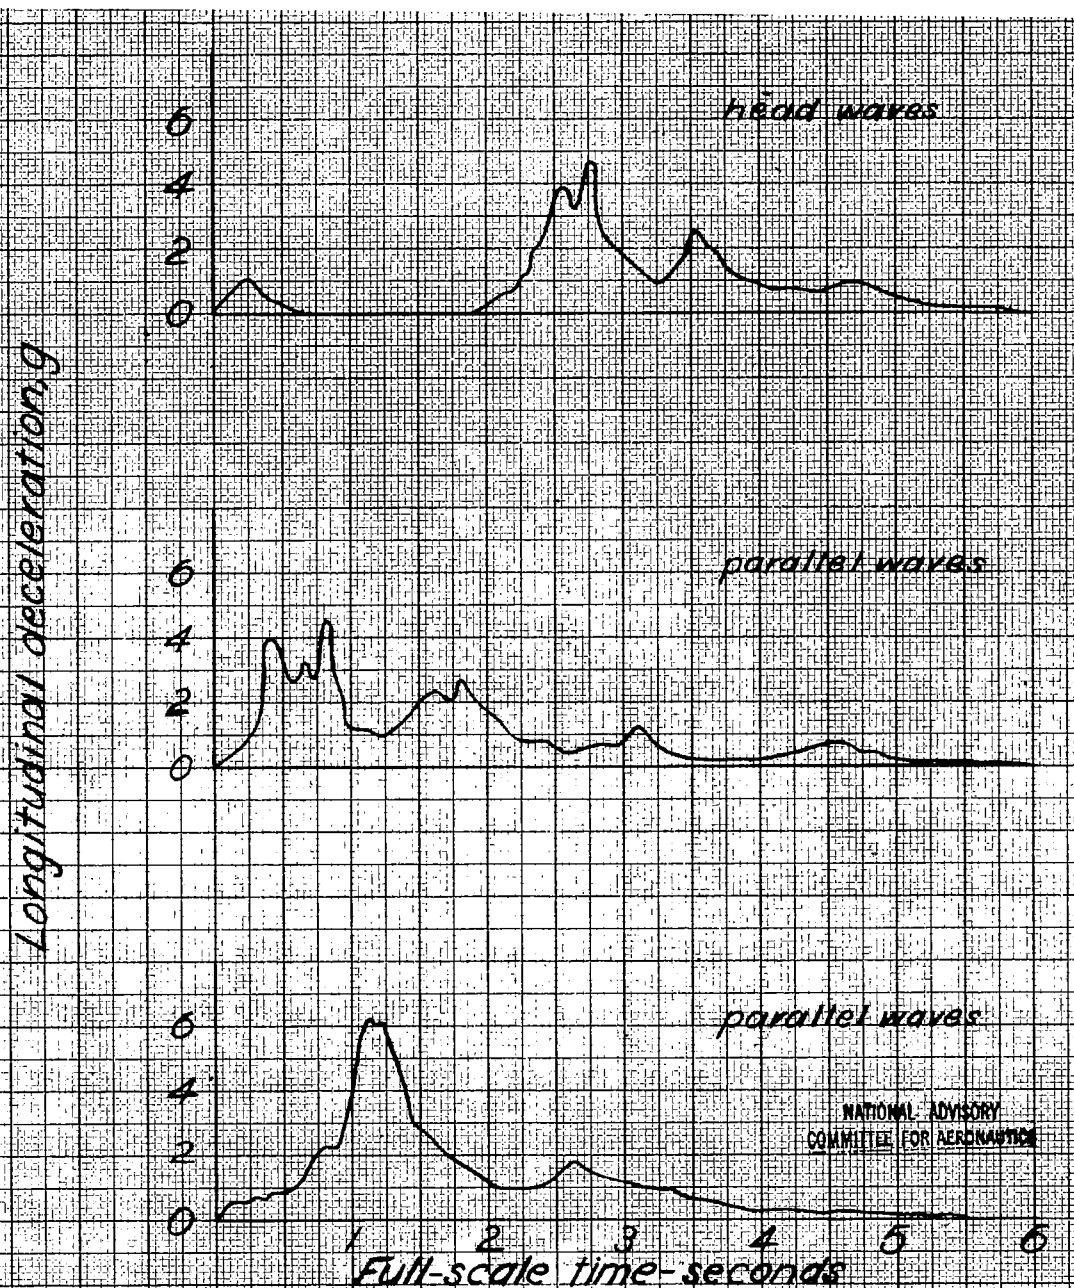
Figure 12-Time history of longitudinal decelerations of a $\frac{1}{11}$ -size model of the Army B-25 airplane, ditched in various conditions of seaway. (Attitude of thrust line, 9°).

Time-history records of longitudinal accelerations are shown in figures 12 and 13.

At high attitude, smooth landing runs generally resulted. At low attitudes skipping, porpoising, or turning occurred. In tank tests the maximum decelerations were less than 5g, while the average of these maximum values for all conditions tested was less than 3g. The decelerations at the outdoor catapult in rough water were higher and of the order of 4g to 7g. The maximum recorded longitudinal deceleration was in a diving turn in smooth water.

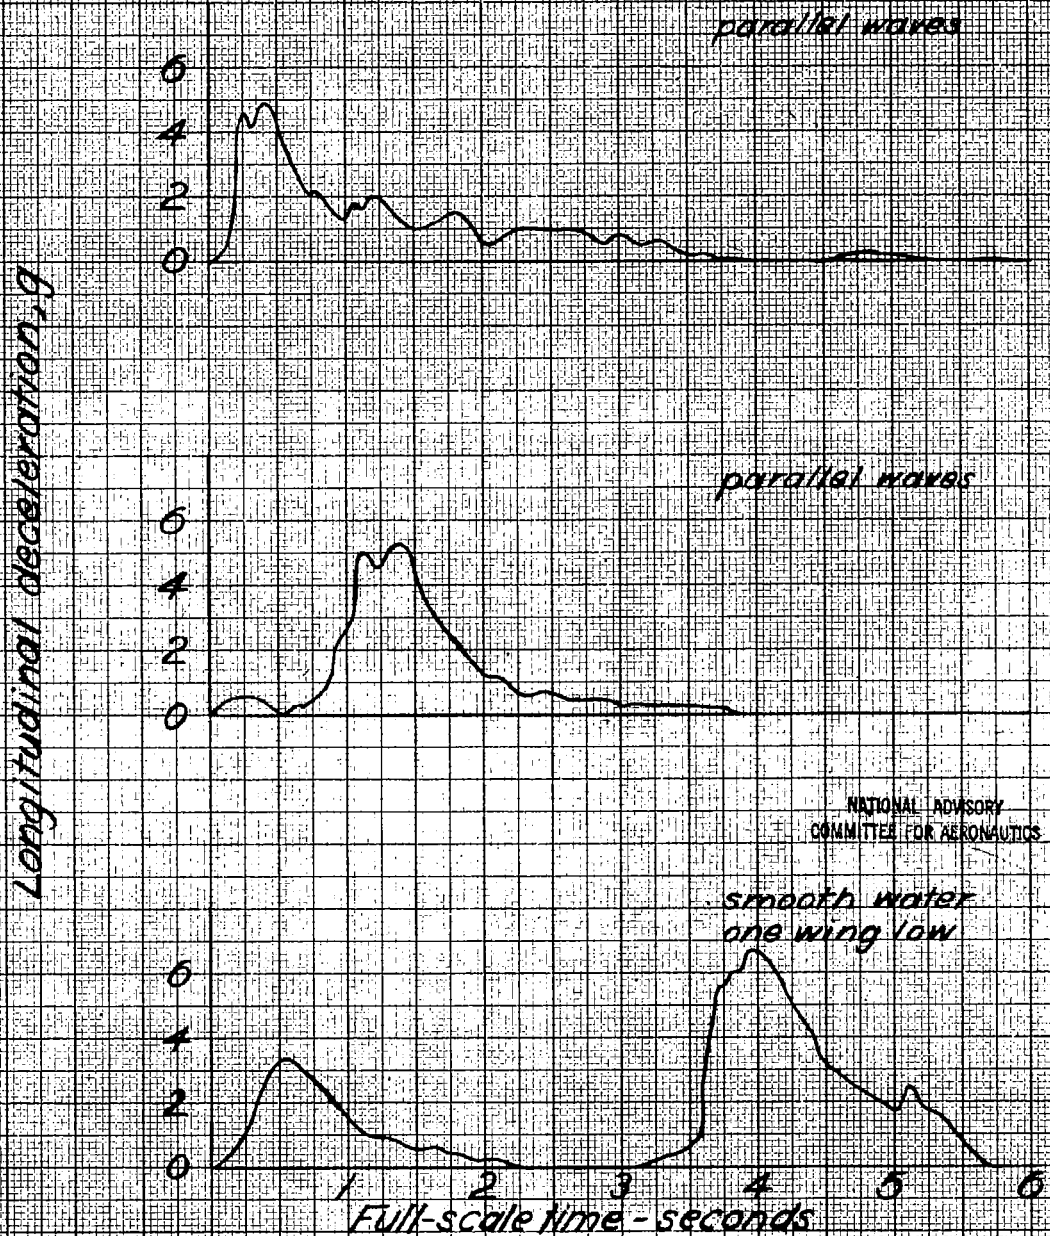
Figure 13. Time history of longitudinal decelerations of a $\frac{1}{10}$ -size model of the Army B-25 airplane, ditched in various conditions of seaway. (Attitude of thrust line, 13°).
